Operations Monitoring Report

Third Quarter FY25

**Thermal Engineering Group, Inc.
105 Hazel Path Court, Ste 2
Hendersonville, TN 37075**

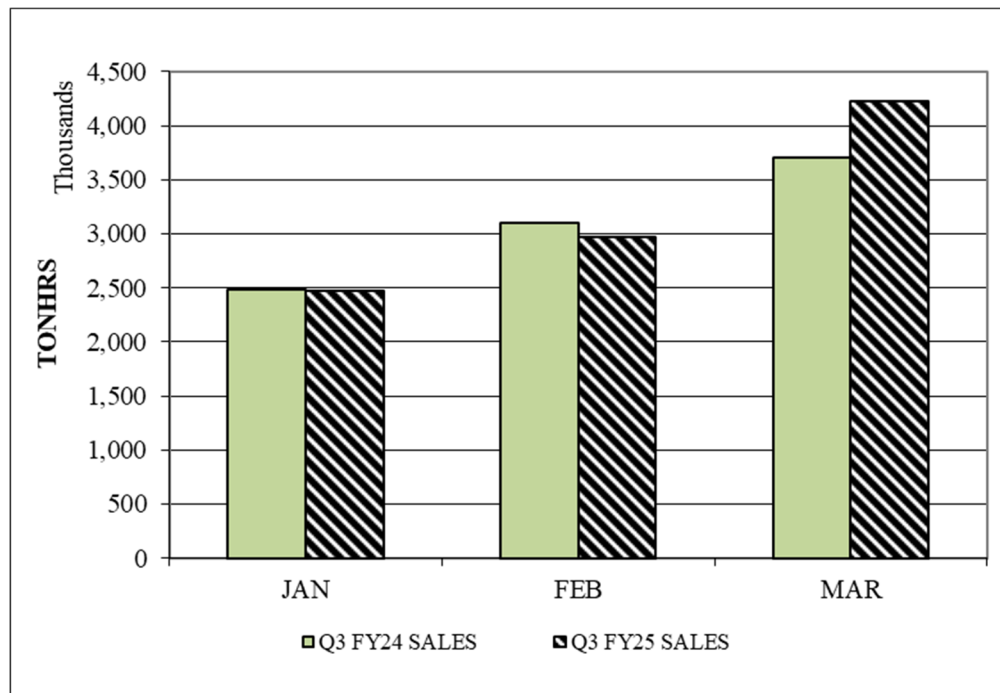
Figure 1. Chilled Water Sales Comparison

A comparison for the Third Quarter chilled water sales is shown in Figure 1. This data reflects 4.1% increase in sales for the current quarter over the same quarter of the previous fiscal year. With an increase of 35.3% in the number of cooling degree days, the change in chilled water sales may be attributable to unusually warm winter.

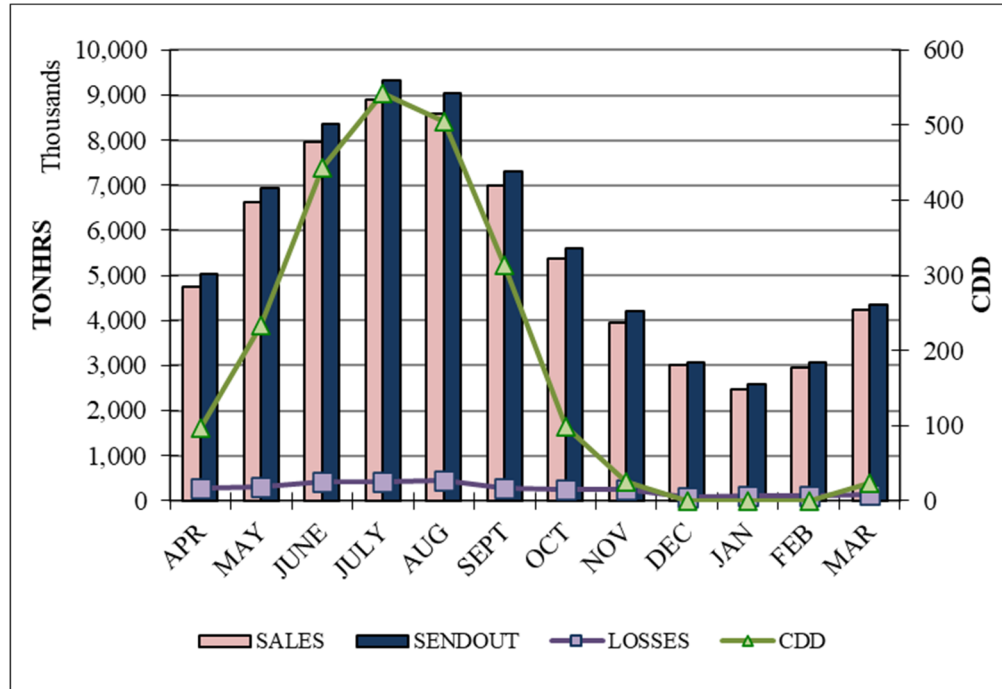
Figure 2. Chilled Water Sales, Sendout, Losses and CDD for the Previous Twelve Months

Figure 2 shows the chilled water sales, sendout and losses for the previous twelve months. The losses in this figure are defined as the difference in tonhrs per month between the recorded sendout and sales values and represent the total energy loss for chilled water in the EDS.

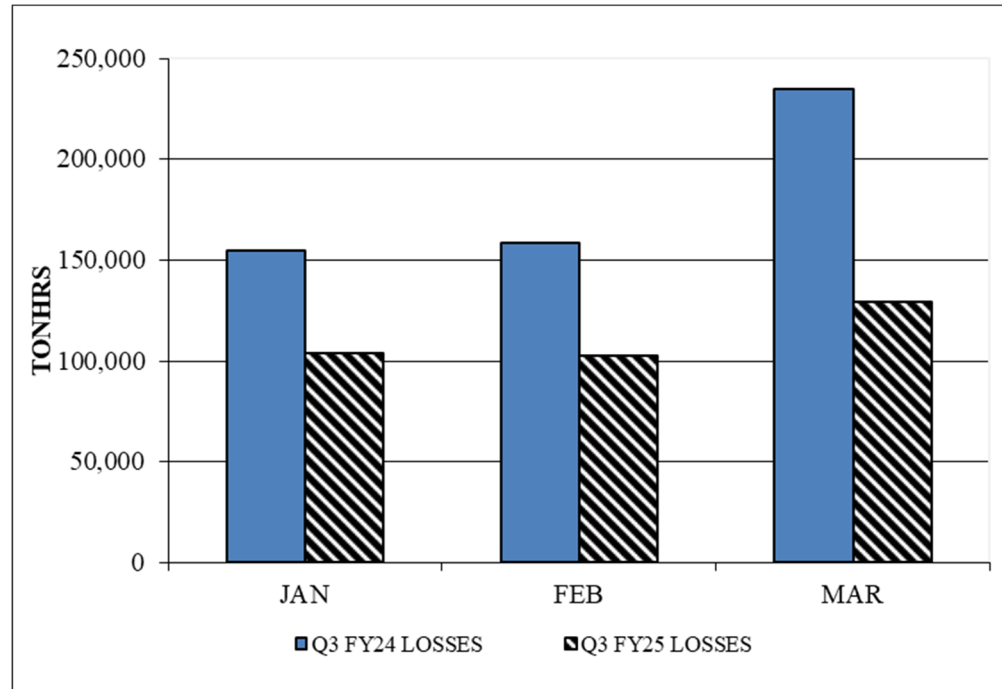
Figure 3. Chilled Water System Loss Comparison

A comparison of the total chilled water energy losses in the EDS for the Third Quarter FY25 is shown in Figure 3. These losses are the difference in chilled water sendout and sales and may reflect differences in the meter accuracy between the EGF sendout meter and the customer meters. The losses decreased 38.8% over the previous Third Quarter.

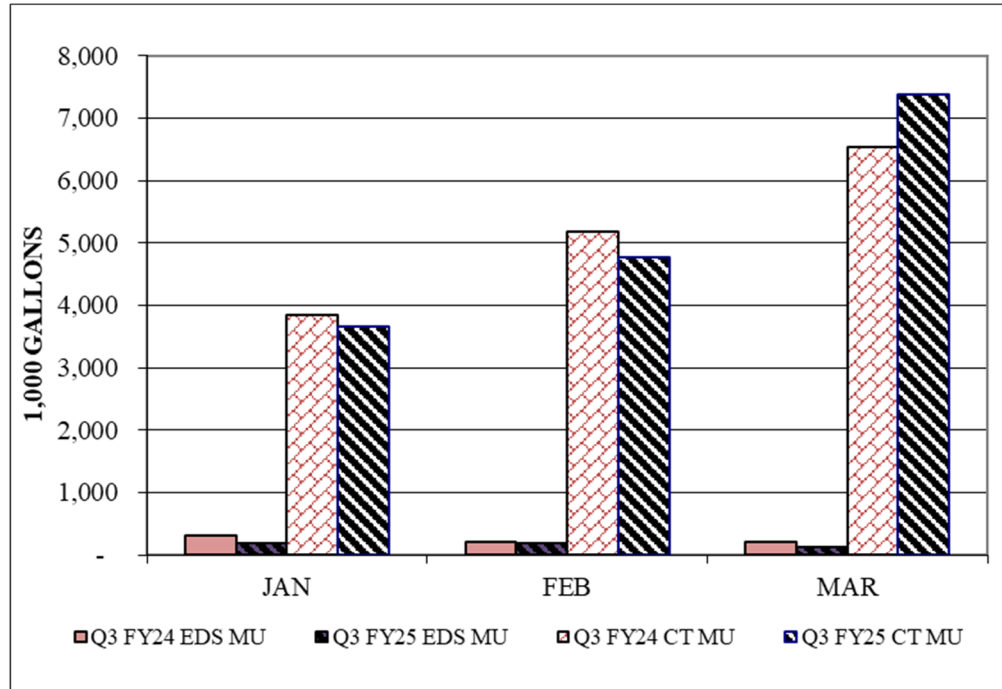
Figure 4. Chilled Water System City Water Usage Comparison

The make-up to the cooling towers increased 1.5% over the previous Third Quarter. The water usage in the cooling towers is typically proportional to the production of chilled water and should vary with chilled water sales. Since the chilled water sales increased over the previous quarter, the amount of heat rejection through evaporation in the cooling towers would be expected to increase. The total chiller plant water use remained approximately the same as in the previous Third Quarter. The overall city water make-up comparison for the chilled water system Third Quarter is shown in Figure 4.

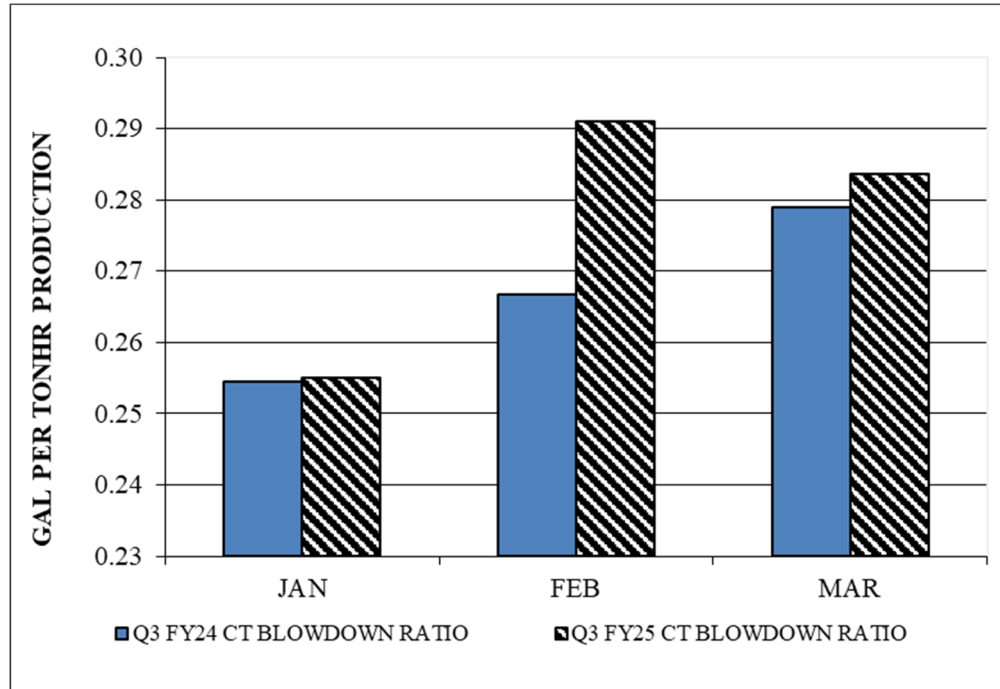
Figure 5. Cooling Tower Blowdown Ratio Comparison

The cooling tower blowdown is monitored and controlled to maintain the conductivity of the condensing water within a range of 1,000 to 1,150 micromhos. The relationship between the cooling tower blowdown and the chilled water production should be consistent and tracking this relationship may prove helpful in reducing the chiller plant make-up water usage. DEAO has made operational changes with respect to the ratio of the cooling tower blowdown to the chilled water production over the past several quarters with the expectation of reducing the water usage and improving their performance relative to the chilled water-water guarantee. A comparison of the Third Quarter values between FY24 and FY25 are shown in Figure 5.

When a comparison is made between the Third Quarter FY25 and FY24, the average cooling tower blowdown ratio increased 3.8%. This value corresponds to meeting the chilled water-water performance guarantee for each month during the quarter. The cooling tower blowdown ratio metric will continue to be tracked and monitored to verify the operational changes made by DEAO at the EGF continue to result in a decrease in chiller plant water usage. Based on the data review in recent months, a blowdown ratio of 0.27 to 0.28 gallon per tonhr appears to result in improvement performance.

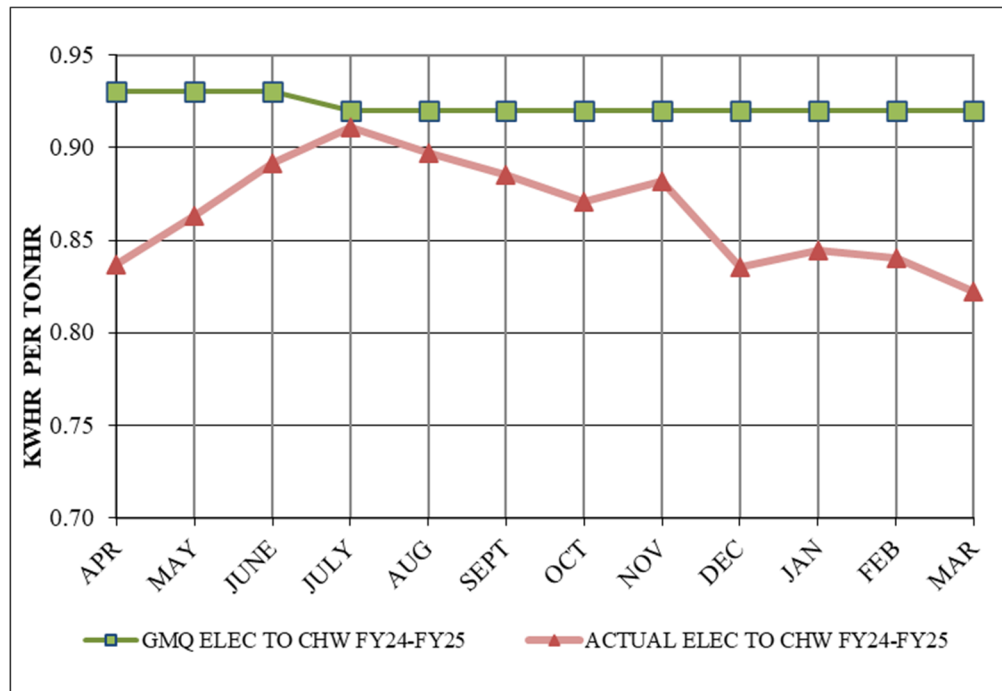
Figure 6. Chiller Plant Electric Performance Guarantee Comparison for the Previous Twelve Months

The performance of the chilled water portion of the EGF is presented in the following two charts, Figures 6 and 7, for the previous twelve months. The System Performance Guarantee for both metrics changed with Amendment 3 beginning with July 2024.

The electricity usage per unit of sales remained approximately the same as in the previous Third Quarter indicating a consistent efficiency. DEAO and TEG continue to monitor the improvements created by DEAO’s operational changes.

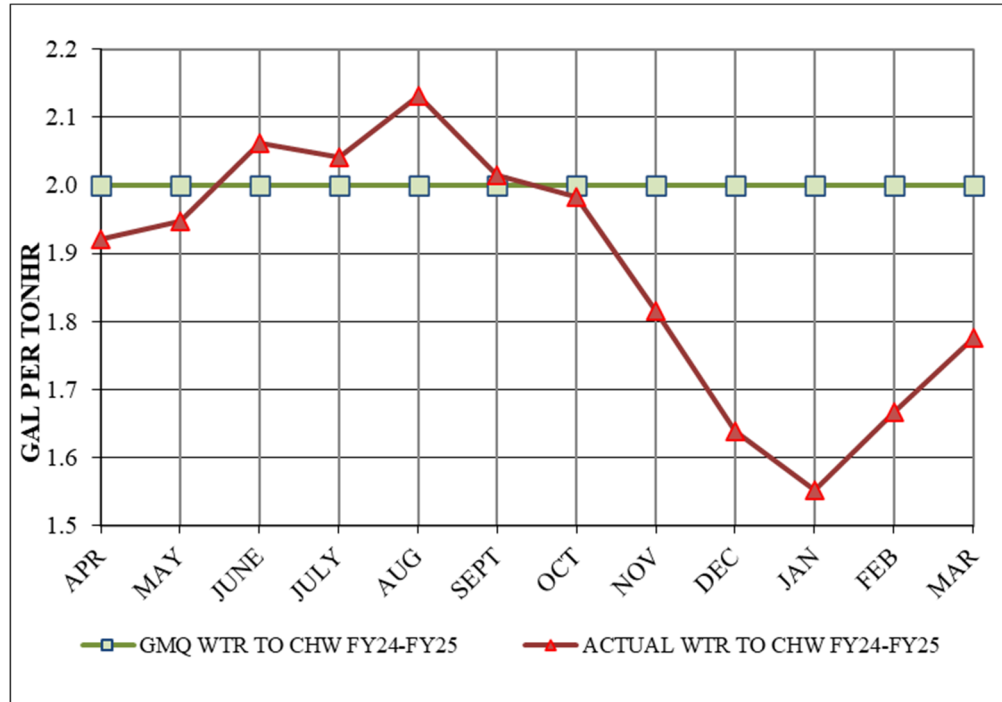
Figure 7. Chiller Plant Water Consumption Performance Guarantee Comparison for the Previous Twelve Months

The total consumption of city water for the chiller plant for the current quarter remained approximately the same as in the previous Third Quarter. The EDS make-up decreased 34.1%, but the cooling tower blowdown increased 5.5%. The side stream filter backwash decreased 74.4% indicating cleaner chilled water. DEAO met the new chilled water-water performance metric each month during the quarter. Figure 7 shows the metric for the previous twelve months. The calculation for the “actual” water metric for months prior to July 2024 uses the methodology from Amendment 2. The FY25 data uses the Amendment 3 methodology. TEG and DEAO continue to monitor the water usage and chiller plant performance with the goal of decreasing the energy and water usage for the system.

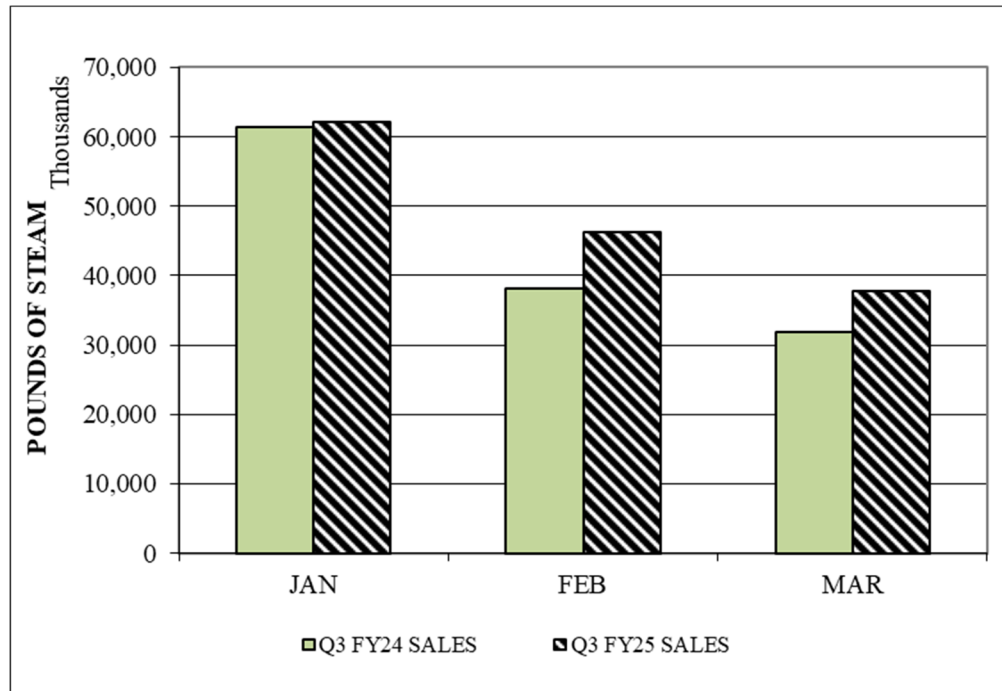
Figure 8. Steam Sales Comparison

The steam sendout increased 8.2% over the previous Third Quarter (FY24), and the sales increased 11.1%. The number of heating degree days increased 35.0% over the previous Third Quarter. The steam system losses decreased 18.3%. The relative amount of condensate return decreased 13.2%; multiple condensate leaks were found and repaired during the quarter resulting in the decrease in the relative amount of condensate returned to the EGF. The peak steam demand for the current quarter is 130,675 pph, which reflects a 10.3% decrease in the peak steam production over the previous Third Quarter. A lower peak steam demand with a higher volume of sales suggests a more consistent load occurring over the quarter relative to the Third Quarter FY24. A comparison for the Third Quarter steam sales is shown in Figure 8.

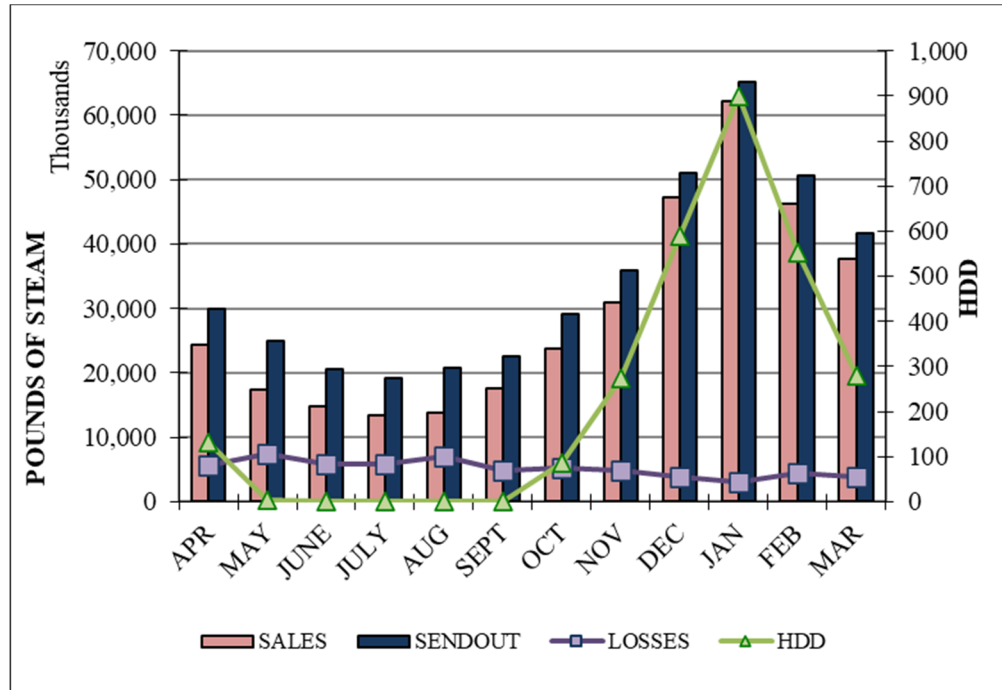
Figure 9. Steam Sales, Sendout, Losses and HDD for the Previous Twelve Months

Figure 9 shows the steam sales, sendout and losses for the previous twelve months. The losses on this figure are defined as the difference in pounds per month between the recorded sendout and sales values and represent the total mass loss in the EDS between the EGF and the customer meters.

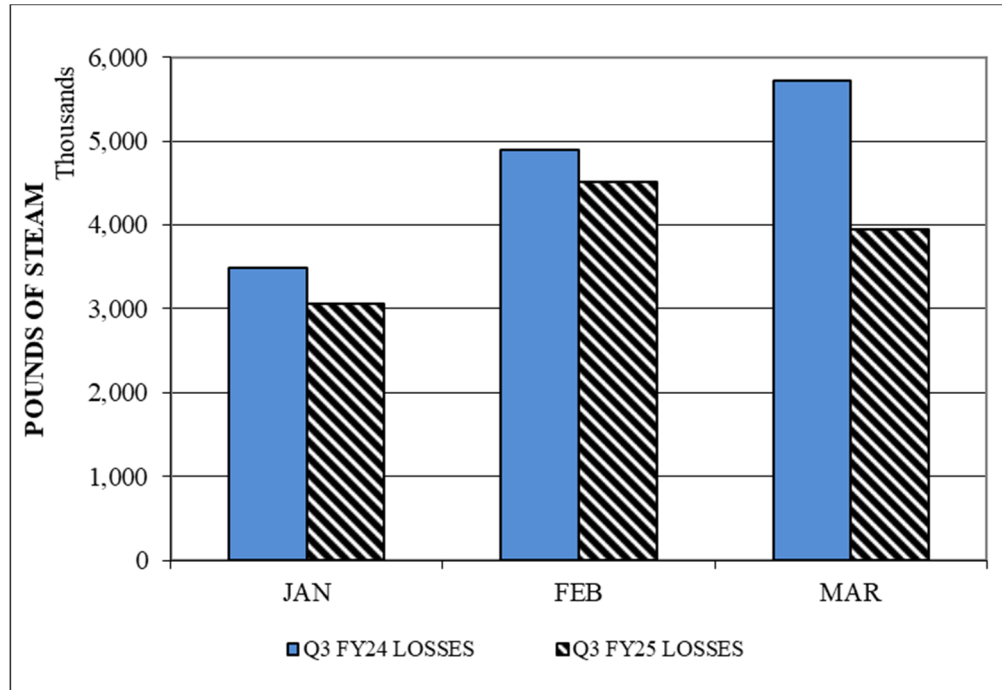
Figure 10. Steam System Losses

A comparison of the total steam mass losses in the EDS for the Third Quarter is shown in Figure 10. The mass loss is caused by the heat loss in the EDS between the EGF and the customer meters, resulting in a mass loss at steam traps. Faulty traps, steam leaks or meter error could also be a contributing cause of these losses.

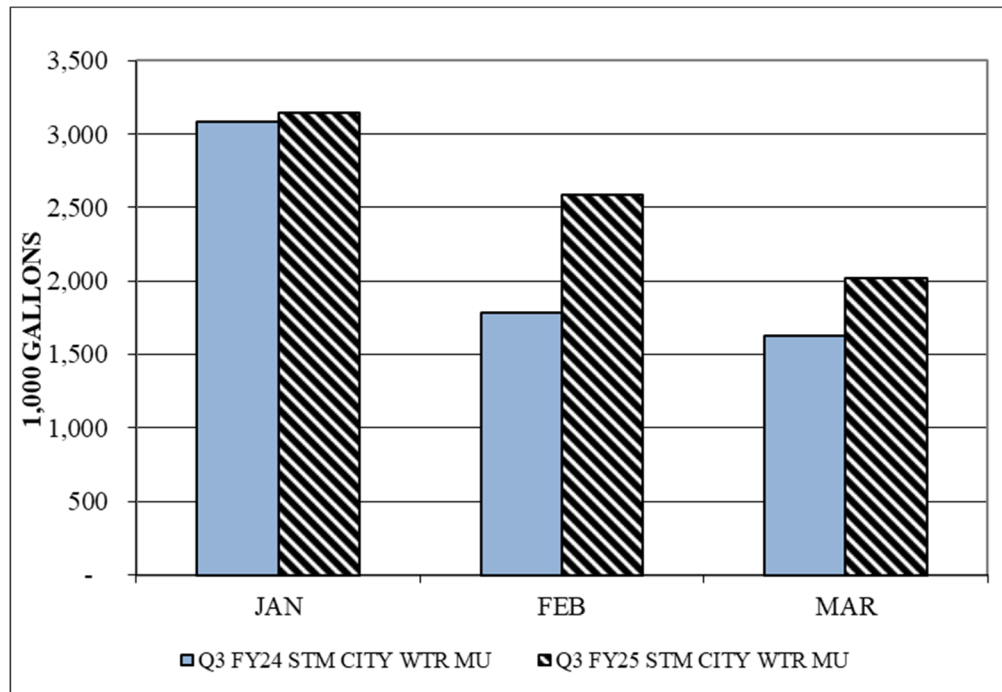
Figure 11. Steam System City Water Make-up Comparison

The amount of city water make-up (MU) to the steam system consists of the loss in mass between the EGF and the customers, in the condensate return from the customers to the EGF and losses at the EGF. The amount of make-up to the steam system increased 19.3% over the Third Quarter FY24. Multiple condensate leaks were found and repaired during the quarter. These leaks resulted in an increase in the make-up water to the steam system. Make-up to the system is anticipated to be less in the Fourth Quarter since the leak repairs have or will be made by the end of April. The corresponding data for steam system make-up is shown in the comparison of Third Quarter data in Figure 11.

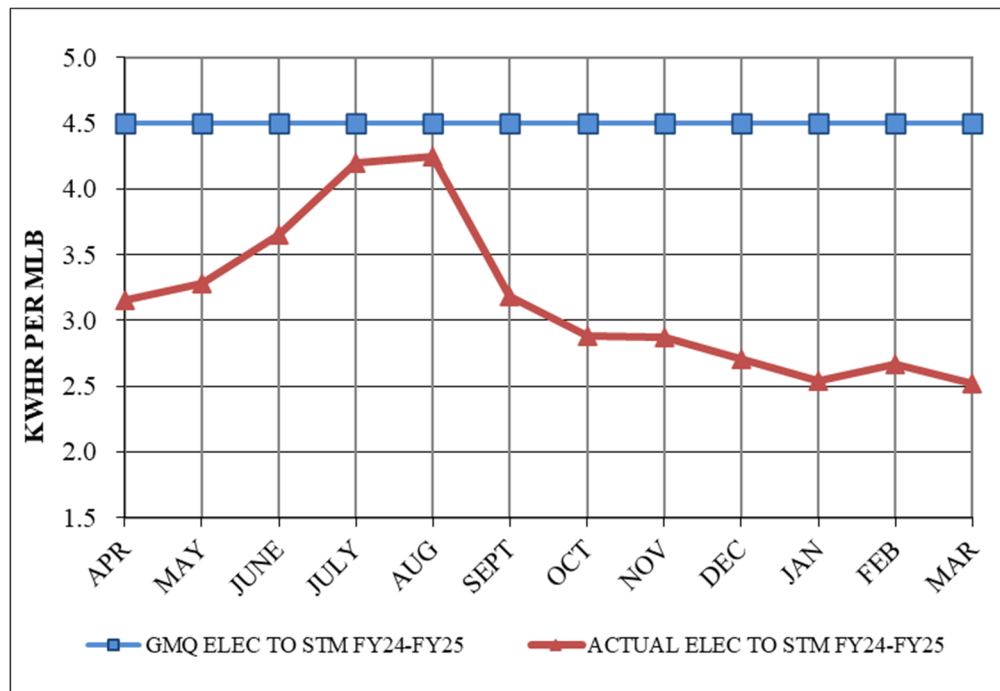
Figure 12. Steam Plant Electric Performance Guarantee for the Previous Twelve Months

The steam electric conversion factor was met each month of the quarter. The steam plant electric consumption for the current quarter was 6.9% higher in FY25 than in FY24. The steam-electric metric decreased 6.9% over the previous Third Quarter. The monthly steam-electric conversion factors, along with the guaranteed values, are shown in Figure 12.

The performance of the steam system of the EGF is presented in the following three charts, Figures 12, 13A, 13B, and 14. With Amendment 3, the steam-electric and steam-fuel metrics and their calculation methodology remain unchanged from Amendment 2. The determination of condensate return with Amendment 3 uses a real time density correction on the condensate return flow rate such that a comparison on the steam sendout and condensate return could be made on a mass basis. DEAO completed the modifications necessary to capture the density-corrected condensate return during the Second Quarter FY25 and completed the necessary changes to determine the monthly condensate return temperature in the Third Quarter.

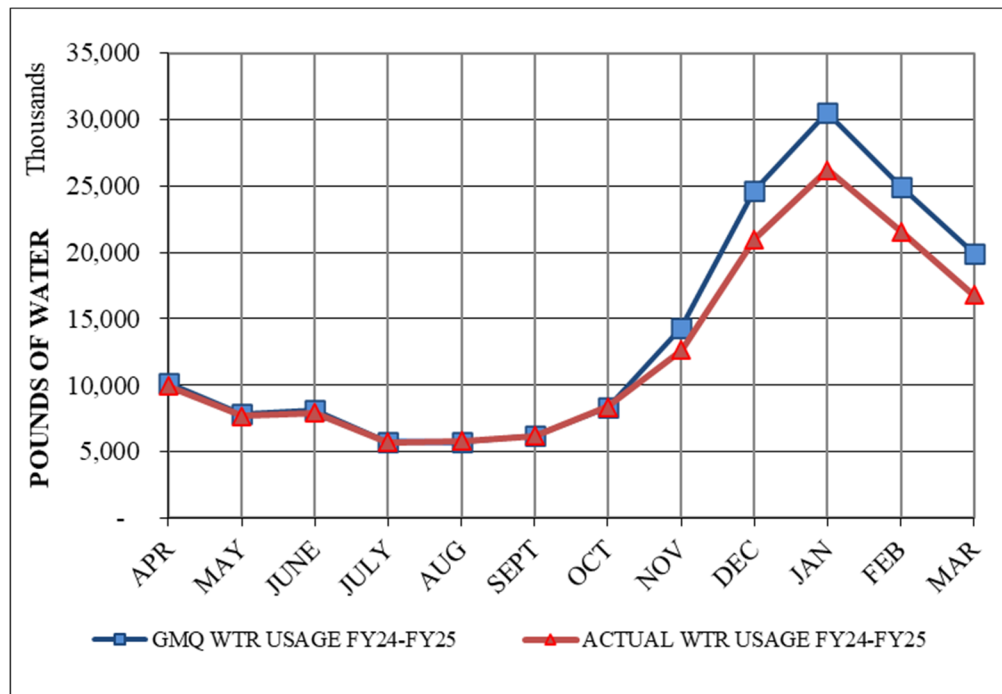
Figure 13A. Steam Plant Water Performance Guarantee for the Previous Twelve Months Using a Mass Comparison

Figures 13A and 13B show the steam-water metrics using two different methodologies. Since the Amendment 3 metric is based on pounds of water and the Amendment 2 metric is based on gallons using a different equation to determine both the GMQ and “actual” values, a comparison is difficult to make between the

historic values and the Amendment 3 equation. Therefore, the performance for the previous twelve months is represented by two different graphs.

Figure 13A uses pounds and Figure 13B uses gallons. The guaranteed and actual volumes (gallons) prior to July 2024 use the Amendment 2 methodology. However, the GMQ volumes shown for FY25 convert the pounds values to gallons assuming a density based on the average condensate return temperature. Similarly, the mass values shown for data prior to July 2024 assume a constant density over the month based on the recorded average monthly condensate return temperature and converting the volumetric data to mass (pounds). These conversions will need to be made for FY25 and until enough historic data using the Amendment 3 methodology has been collected such that the real time density correction will be recorded.

For the Third Quarter, the boiler plant water usage increased 19.3%. This increase resulted in an 18.1% increase in the steam-water metric with the volumetric comparison methodology from Amendment 2 and a 19.3% increase with the density correction formulation similar to Amendment 3. Using the Amendment 3 methodology, the metric was met each month during the quarter. Please note the performance metric is based on the actual amount of condensate return each month resulting in a variation in the GMQ value.

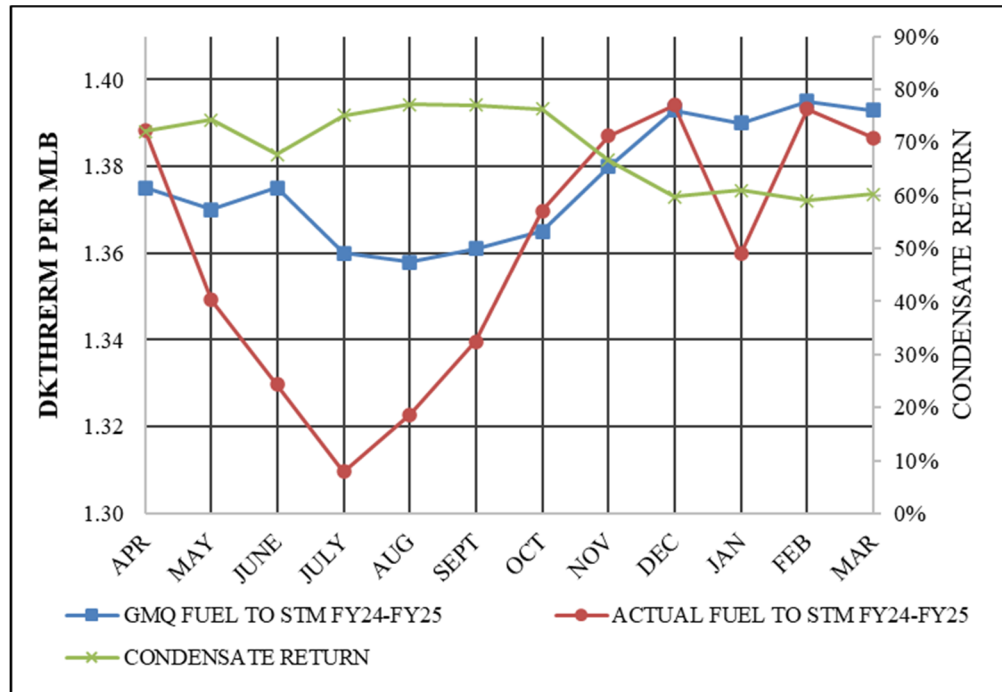
Figure 14. Steam Plant Fuel Performance Guarantee for the Previous Twelve Months

The steam-fuel metric did not change in Amendment 3; however, the relative amount of condensate return is reported using the mass flow values determined by the density corrected values used in the steam-water metric. The actual steam-fuel metric was met each month during the Third Quarter. The fuel consumption per unit of steam sendout increased marginally over the previous Third Quarter. The relative amount of condensate return is shown on this graph to reflect the influence the condensate return has on the plant efficiency.

Figure 14 shows the performance of the conversion factors for the previous twelve months.

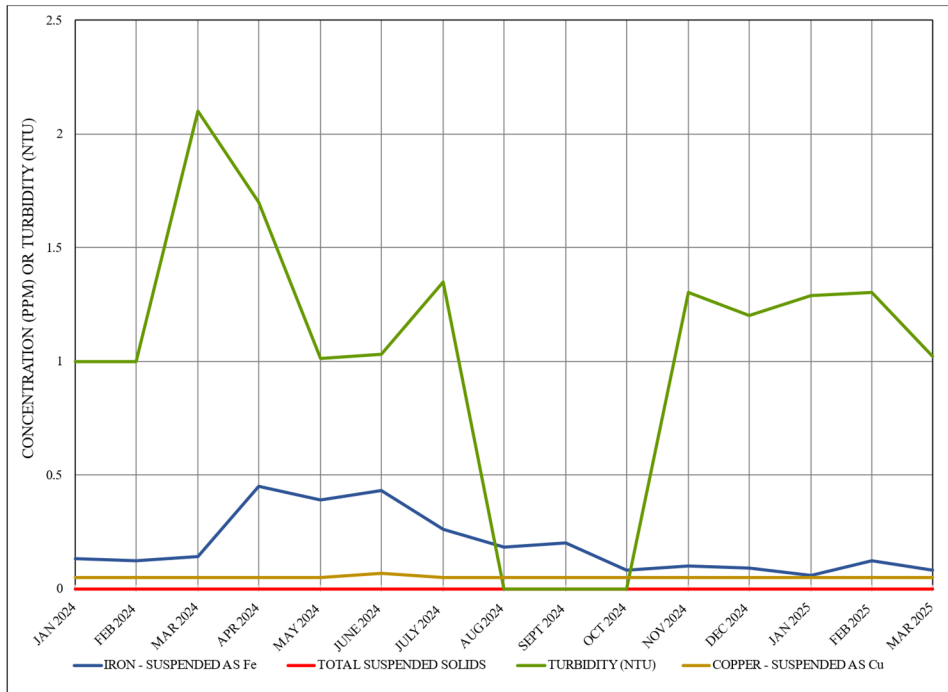
Figure 15. Chilled Water Composition Downstream of Side Stream Filter

- The side stream filter has significantly reduced the amount of suspended solids in the chilled water and improved the turbidity of the system.
 - Figure 15 shows the results of several measured metrics within the chilled water system which may be affected through the use of the side stream filter.
-

Values shown at or near zero may be at or below the detectable limit and are represented by “zero” on the graph.
